INFOSHEET 1.78

Early Version Holland Fleetmaster Fifth Wheels

HOLLAND FLEETMASTER FW 8 FIFTH WHEEL

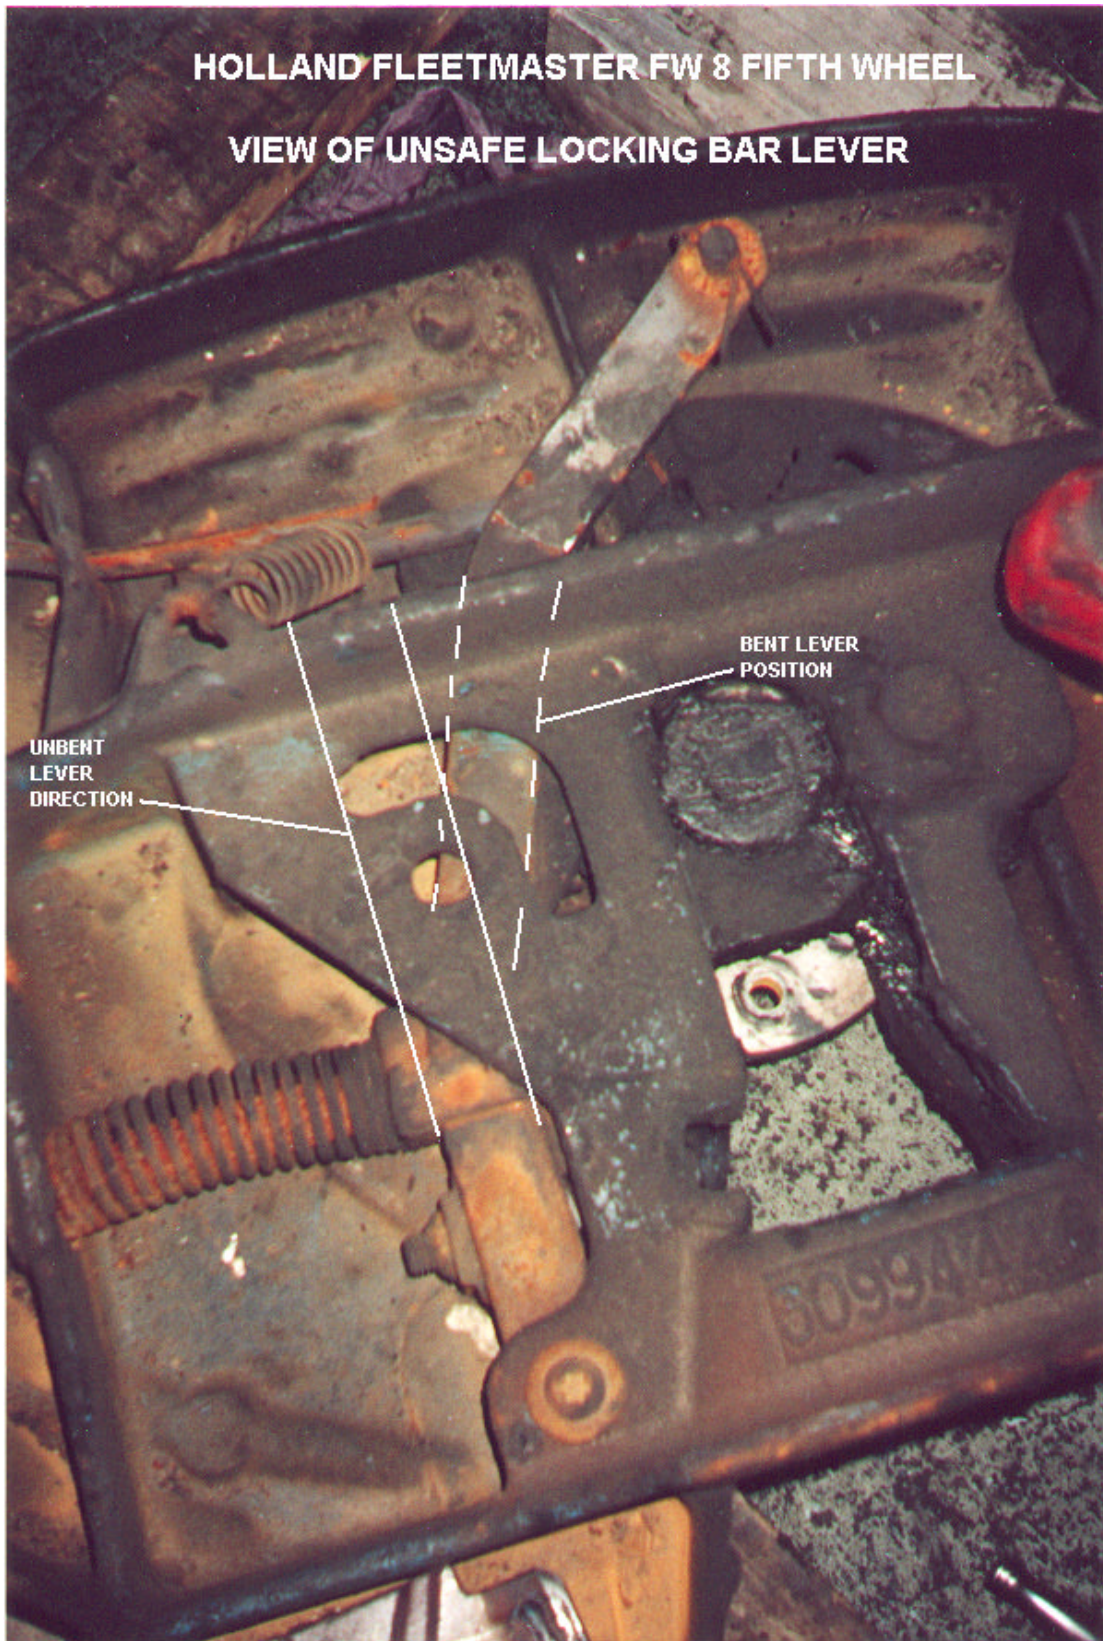
The cause is shown in the attached photograph, looking at the underside of a fifth wheel (see page 3). High and fast lock-ups on a partially closed jaw can cause the locking plunger to be driven laterally away from the throat of the fifth wheel. The locking plunger is located on the hinged arm, which is attached to the release handle at its outer end. During high and fast lock-ups, the force on the jaw is sufficient to bend the hinged arm once the release handle stop has reached the fully home position.

Once bent, the hinged arm no longer allows the locking plunger to move forward sufficiently to engage the jaw in the closed position. The amount of locking capability will vary according to the degree that the arm is bent and the locking plunger withdrawn. The jaw may lock sufficiently to enable the tractor to appear adequately coupled to the trailer, reach highway speed, and then disconnect.

The position of the release handle alone IS NOT a sufficient indication that a safe lock-up has occurred. Nor is it sufficient to jerk the trailer with the tractor after lock-up. If the nose of the locking plunger cannot be seen, the mechanism has been damaged, and the fifth wheel is **DANGEROUS AND MUST NOT BE USED UNTIL REPAIRED.**

VIEW OF UNSAFE LOCKING BAR LEVER

Visual inspection of the hinged arm is misleading. A mechanism in an unsafe condition can best be detected by looking from the rear into the throat of the fifth wheel once the jaw has locked around the kingpin. The fifth wheel is safe if, with the release handle fully home, the nose of the locking plunger is clearly visible. This is fully described in the Holland Operating and Repair instructions.

Maintenance personnel servicing tractor units cannot use a standard kingpin to adjust the jaws of this model of fifth wheel. The correct Holland TLN1000 or TLN5000 lock tester must be used to prevent over-adjustment and subsequent disconnection. Correct adjustment of the jaw using the Holland gauge leaves the jaw with a small clearance around the kingpin when the kingpin is in the locked position.
