Errata for VIRM: In-service certification (WoF and CoF) , version3, amendment 4, November 2008

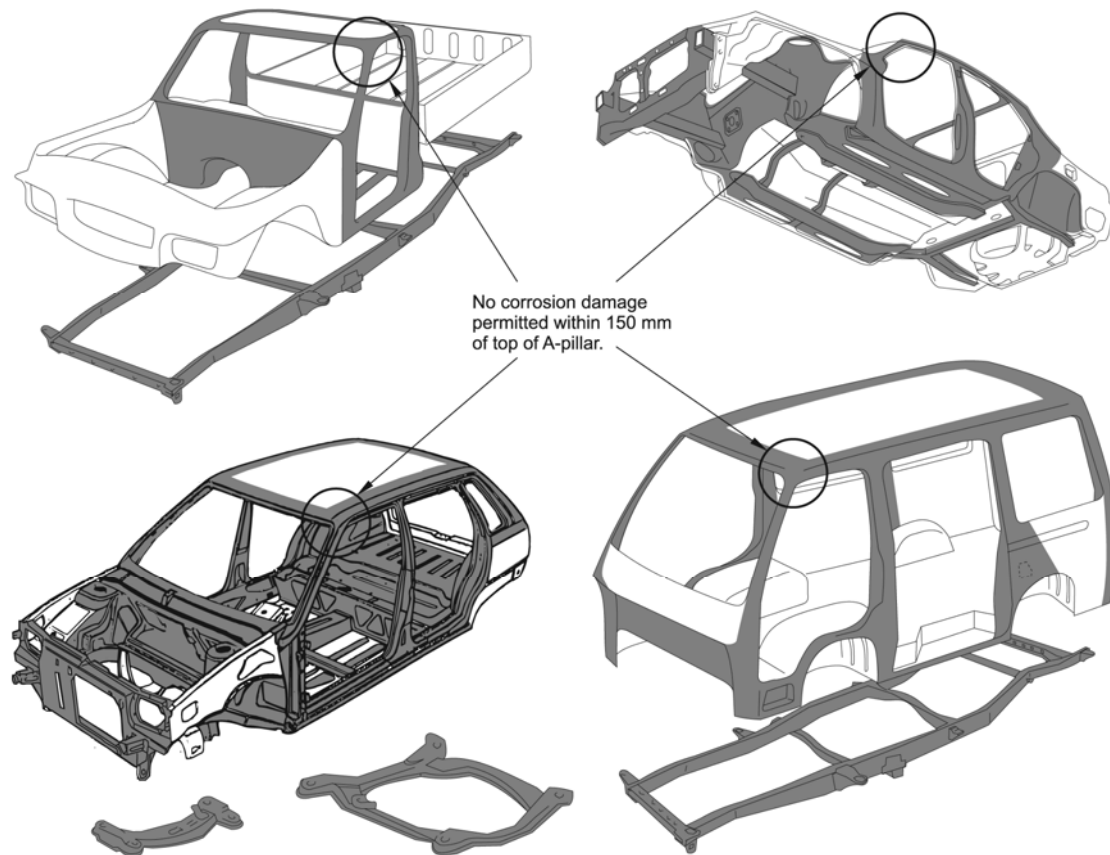
General Vehicle page 3-1-4, Figure 3-1-2: the frontal structure (radiator support panel etc) should be shaded, as below:
