# The Ins and Outs of Roundabouts

Safety Auditors' Perspective

April 2000

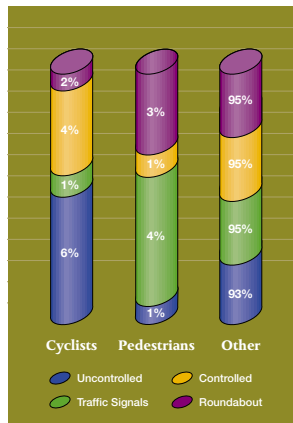
As shown, cyclists account for 6% of accidents at roundabouts, 1% at traffic signals and 4% at priority controlled intersections, further highlighting the need for special consideration for cyclists at roundabouts.

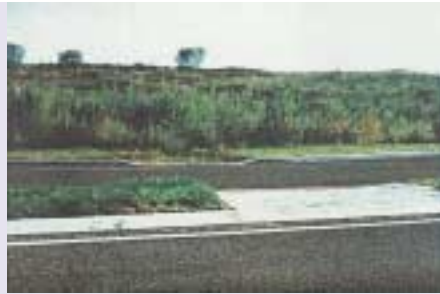
- Rear end accidents resulting from poorly sited crossing locations.
- Severance of existing pedestrian routes without making suitable alternative provision.

*Pedestrian ramps leading nowhere*

- Clear, safe guidance of pedestrian to appropriately located facilities.
- Provision of guard fences and hand-rails to control pedestrian movements.
- Locating pedestrian facilities as far from the roundabout as possible without reducing the attractiveness of facility.

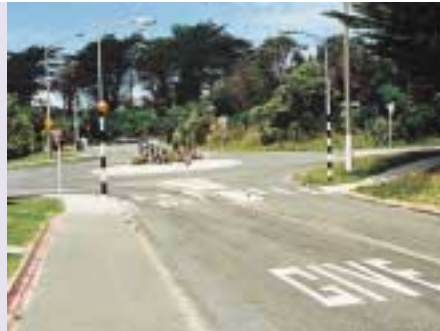
*Good pedestrian design with linking paths and clear visibility*

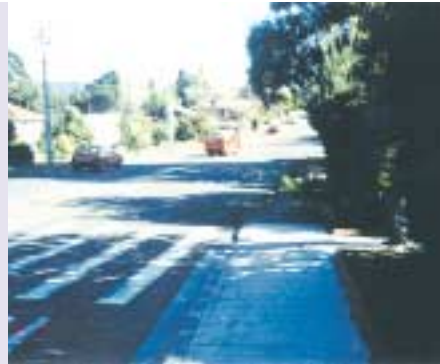
- Poor intervisibility with approaching drivers.
- Inadequate stopping sight distance for motorists.
- Crossing points not being located on pedestrian desired routes.
- Poor design or lack of provision of drop-crossings.

*Shadow across crossing and vegetation hiding pedestrian*

- Always ensure adequate intervisibility between drivers and pedestrian facilities.
- Realign adjacent footpaths to guide pedestrians to crossing locations.
- Judicious planting/street furniture/fences to discourage pedestrians from crossing at hazardous locations.
- Ensure that all pedestrian crossing points have smooth kerb ramps.

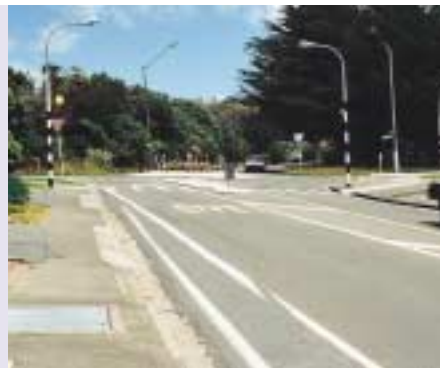
*Good clear sight lines with pedestrian and motorist*

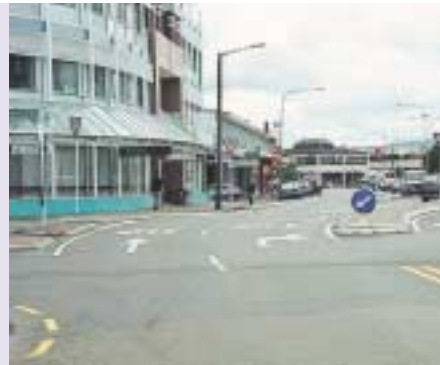
- Failure to give way to vehicles already on the roundabout.
- Rear end collisions when vehicles brake suddenly.
- Loss of control accidents within the area of the roundabout.

*No deflection for straight through traffic*

- Moving the centre of the roundabout.
- Increasing the diameter of the central island.
- Modifying the approach geometry .
- Increasing the deflection by realignment of the approach kerblines or splitter islands.
- Greater use of roadmarkings, including raised reflective pavement markers.

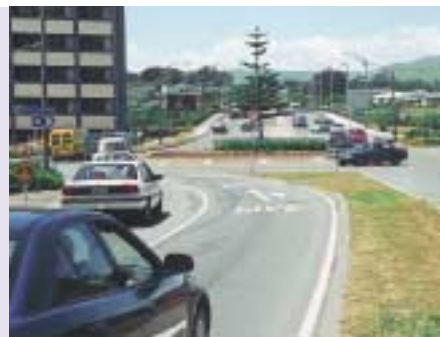
*Deflection provided*

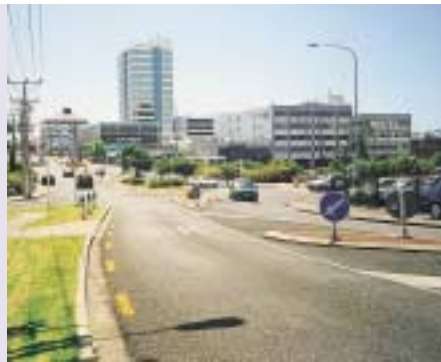
- Loss of control accidents.
- Drivers incorrectly assessing appropriate approach paths.
- Failure to give way accidents.

*Badly aligned median with sharp transition.  
Roadmarking needs to be altered*

- Ensure drivers are guided around the roundabout and not through it.
- Smooth transitions must be provided along edge of the splitter island to ensure approach speeds are reduced gradually (ie avoid abrupt deflection at entry to the roundabout).

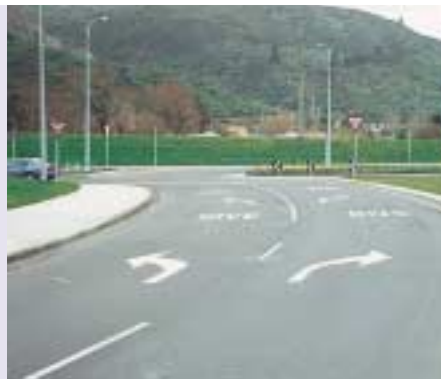
*Good deflection of median further  
highlighted by roadmarking*

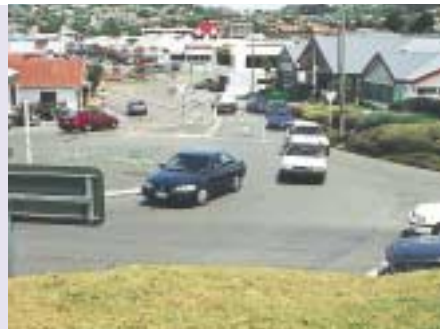
- Lead motorists into unsafe situations and confuse motorists.
- Reduce the capacity of the roundabout to handle the intended traffic volumes.
- Increase speeds through the roundabout.
- Lead to unexpected weaving manoeuvres through the roundabout or on the approaches.

*Multi-lane roundabout providing no guidance to motorists in the circulating roadway*

- Ensure roadmarkings provide a clear indication of what is expected of the driver and other users of the roundabout.
- Remove old roadmarkings to avoid confusion.
- Provide roadmarkings within the circulating roadway.
- Adopt a consistent marking style with nearby roundabouts.

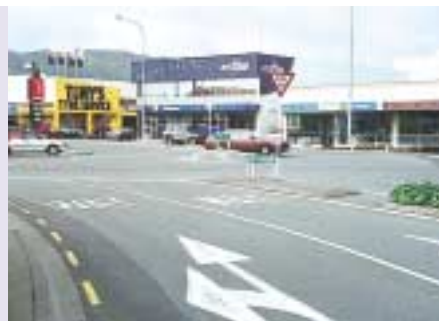
*Good clear roadmarkings provide motorists with clear instructions*

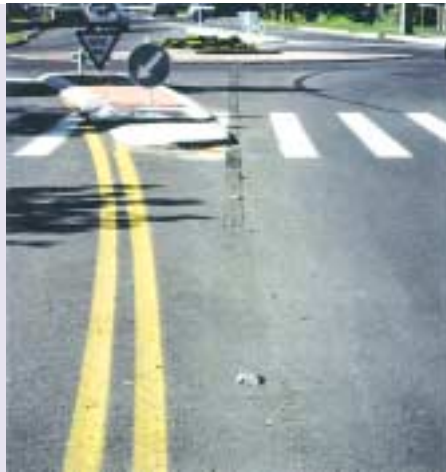
- Old markings can lead motorists into the path of an oncoming vehicle, particularly at night.
- Old signs may incorrectly inform motorists.

*Old markings confuse pedestrians and motorists. Redundant reflective markers misguide motorists*

- Permanently remove all old markings.
- Remove all redundant signs.

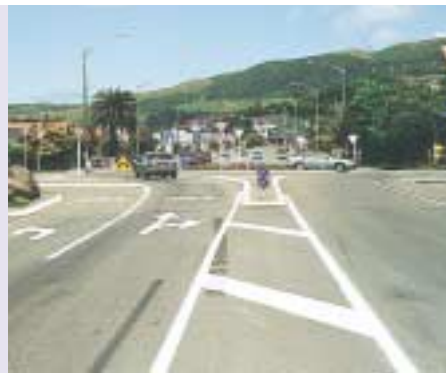
*Good clear roadmarkings*

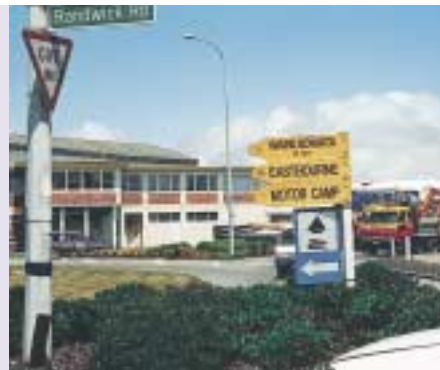
- Confusion for unfamiliar drivers seeking a particular location.
- The inability of the motorists to anticipate the type of junction ahead.
- Reduced driver's vision.
- Last-minute or unexpected lane changing when destination information is provided too late.

*Destination signs hide approaching vehicles*

- Provide larger warning signs on high speed approaches to a roundabout and/or increase the number of warning signs; ie one on each side of the roundabout approaches.
- Install large advance directional signs for major urban and rural roundabout junctions especially at high speed locations.
- Ensure signs do not obstruct critical sight lines.

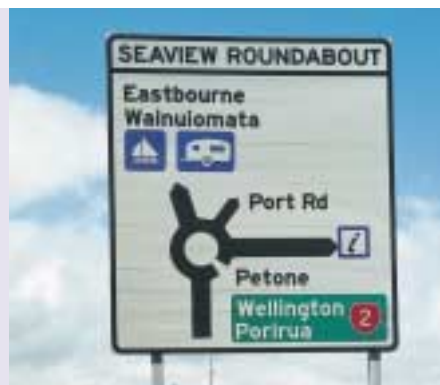
*Good clear directions given to motorists in advance of the roundabout*

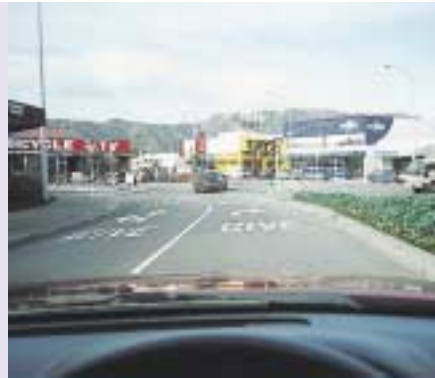
- Motorists losing control because of failure to see central island.
- Vehicles driving through central island.
- Rear-end accidents due to sudden braking
- Inability to determine appropriate roundabout speeds leading in turn to accidents resulting from failure to give way.

*Poor central island design leading to a lack of island recognition*

- Raising central island to improve its visibility.
- Chevron signing to highlight central island radius.
- Lighting of central island at night.
- Design of splitter islands to guide motorists around central island.

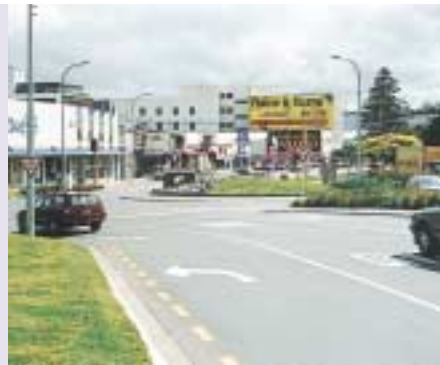
*Raised central island improves the intersection control and its recognition*

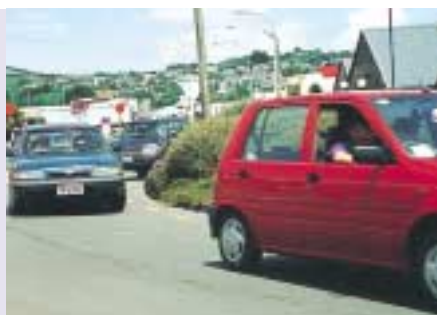
- View is obstructed by signs/vegetation creating blind spots for drivers.
- Efficiency of the roundabout is affected because of extra delays associated with poor visibility.
- Signs and vegetation hide smaller and/or slower moving road-users such as pedestrians or cyclists.

*Approaching vehicles are hidden by vegetation*

- Ensure a regular maintenance programme is in place such that the height of any vegetation does not intrude on sight lines.
- In critical areas provide hard surfaces rather than planting.
- Relocate vegetation away from critical line of sight triangles.
- Remove inappropriate vegetation and plant low ground cover plants.

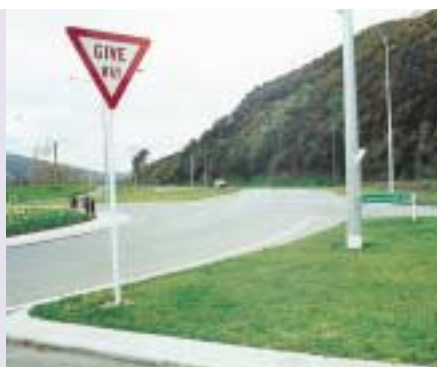
*Excellent visibility provided for motorists*

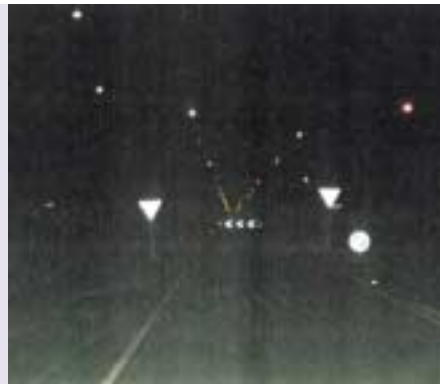
- Confusion, causing emergency braking and/or collision
- Loss of control night-time accidents
- Delays due to poor guidance to motorist

*Streetlights lead motorists straight through the roundabout*

- Consider more lanterns and/or greater luminance.
- Consider central island lighting column.
- Use of reflectorised paint on kerbs and install reflective markers around islands.
- Ensure that all physical elements including splitter islands are clearly lit.
- Adjust lighting on approaches, as necessary to ensure that the junction is recognised.

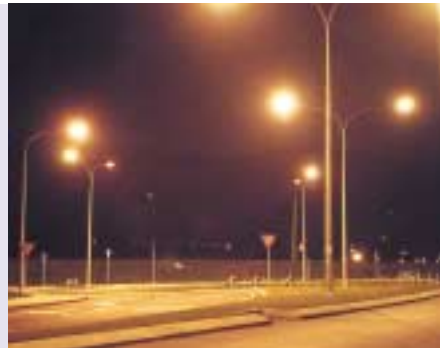
*Street lighting highlighting roundabout and its approaches*

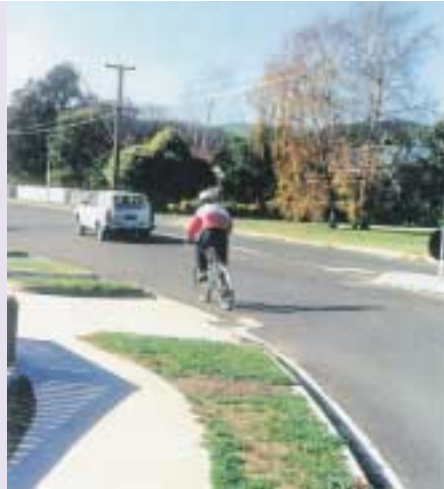
- Stormwater grates, particularly where the grates are orientated parallel to the roadway, are a real hazard for cyclists.
- Cycle lanes, where they are provided along a route typically stop short of roundabouts.
- Large roundabouts with higher circulating speeds create difficulties for cyclists.
- Inadequate lane widths, particularly on circulating roadways shared with heavy commercial traffic.

*End of spitter island is beyond sump forcing rider to the left and onto stormwater grate*

- Avoid use of stormwater grate patterns which are parallel to the direction of travel.
- Avoid locating any service covers within the travelled way.
- Provide adequate clearances to heavy vehicle tracking paths in the design phase.
- Provide adequate circulating lane widths to properly accommodate cyclists.

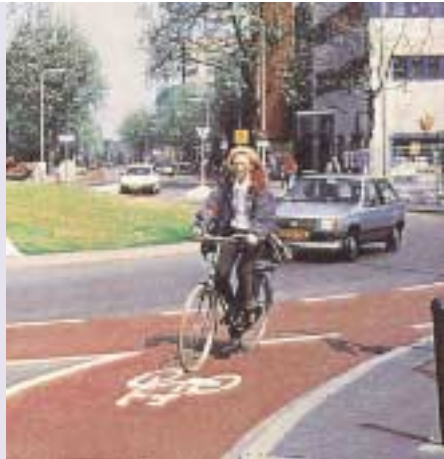
*Typical cycle treatments used overseas*

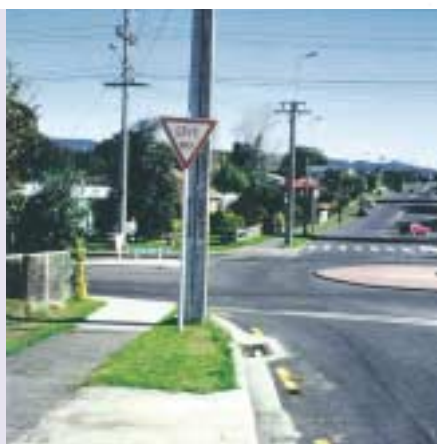
- Motorists hitting obstructions.
- Poor intervisibility with other road users.

*Poor location of solid concrete lamp-post on approach*

- Move lighting columns to back of footpath and use frangible poles
- Ensure signage is kept clear of sight lines.

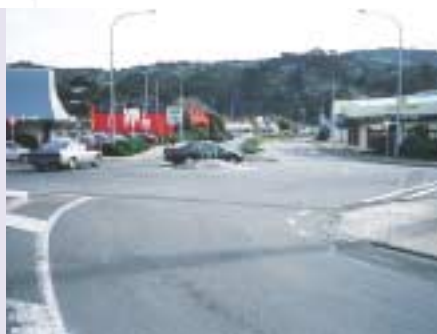
*Street lighting poles located well clear of kerbs*
